Air Quality Monitoring and Sampling Summary Report

Air Quality Monitoring of the Work Zone Perimeter, Localized Weather Patterns

DWR Oroville Dam Recovery

August 11 thru August 24, 2017

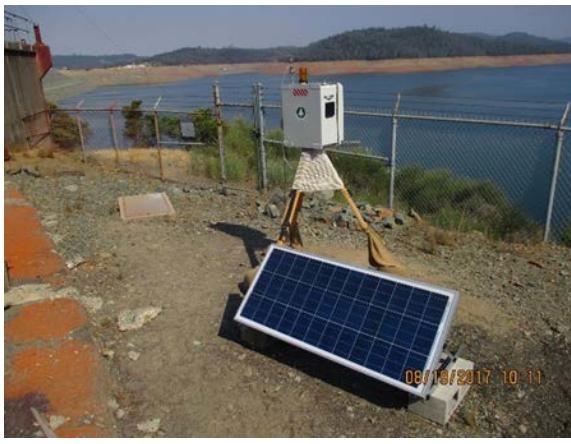
A photograph of an air monitoring station at Station 1. It consists of a white tripod-mounted control unit with a small blue solar panel attached to its side, positioned on a dirt surface. In the background, there is a chain-link fence, some trees, and a large body of water (Oroville Lake) under a clear sky. The date "08/19/2017 10:11" is visible in the bottom right corner of the image.

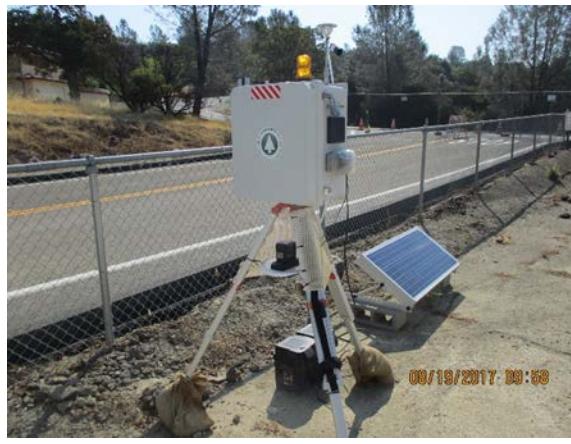
A photograph of an air monitoring station at Station 2. It features a white tripod-mounted control unit with a larger blue solar panel mounted on top, situated on a dirt area near a paved road. A chain-link fence runs along the background. The date "08/19/2017 09:59" is visible in the bottom right corner.
Station 1 – WP 246 Intake Yard	Station 2 – WP 247 Upper Overlook Entry

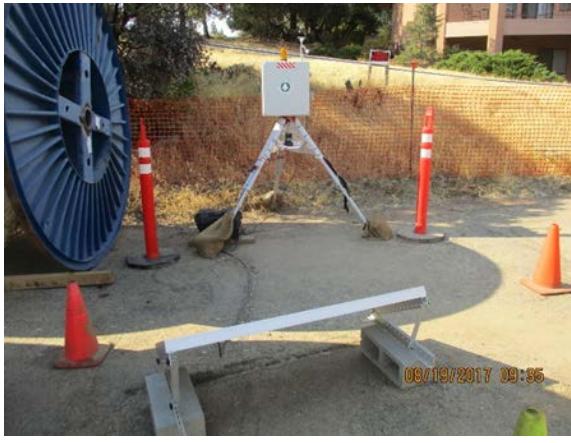
A photograph of an air monitoring station at Station 3. It is located on a paved area next to a large blue circular object, possibly a spool or drum. The station includes a white tripod-mounted control unit with a blue solar panel. Orange traffic cones are placed around the equipment. The date "08/19/2017 09:56" is visible in the bottom right corner.

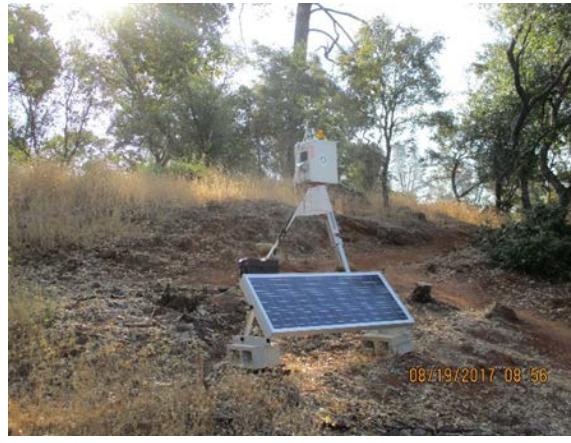
A photograph of an air monitoring station at Station 4. It is set up on a grassy, uneven terrain with trees in the background. The station has a white tripod-mounted control unit with a blue solar panel. The date "08/19/2017 09:56" is visible in the bottom right corner.

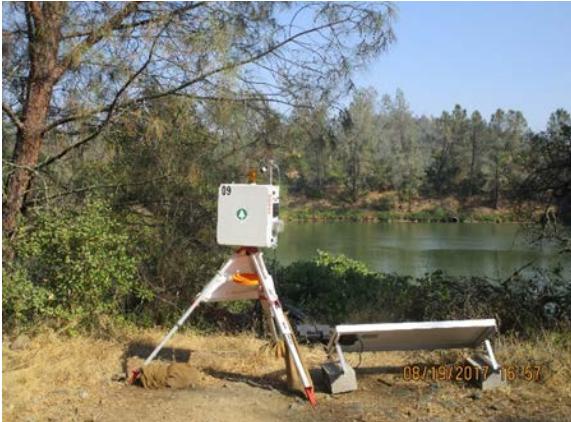
A white rectangular air quality monitoring unit mounted on a tripod stands in a grassy area near a body of water. A solar panel lies on the ground to its left. The date '08/19/2017 16:57' is visible in the bottom right corner of the image.

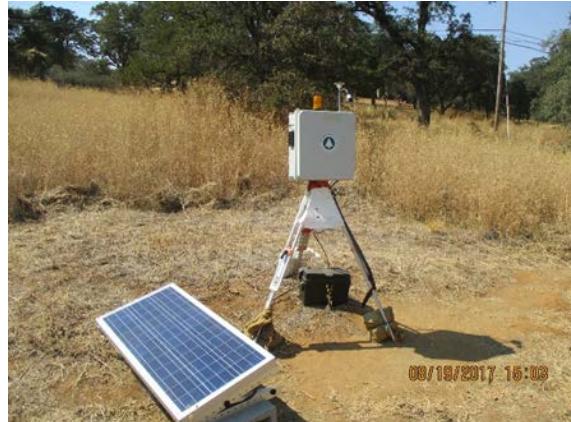
A white rectangular air quality monitoring unit mounted on a tripod stands in a dry, grassy field. A solar panel lies on the ground to its left. The date '08/19/2017 15:03' is visible in the bottom right corner of the image.
Station 9 – 017A Burma Road	Station 10 – WP 281 Cherokee Rd.

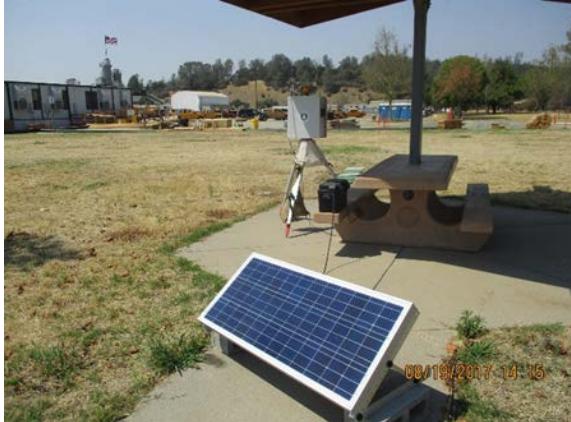
A white rectangular air quality monitoring unit mounted on a tripod stands on a paved surface in a parking lot. A solar panel lies on the ground to its left. The date '08/19/2017 14:15' is visible in the bottom right corner of the image.

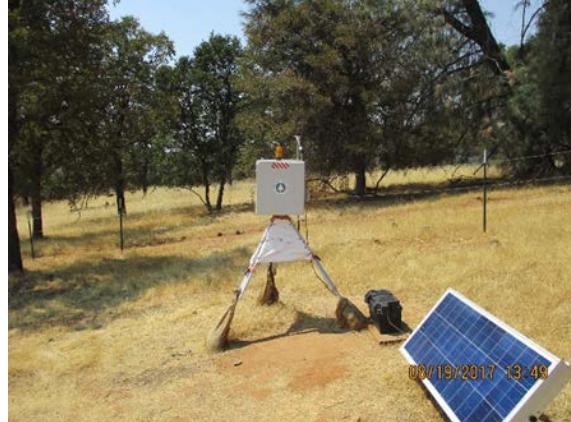
A white rectangular air quality monitoring unit mounted on a tripod stands in a grassy field. A solar panel lies on the ground to its right. The date '08/19/2017 13:49' is visible in the bottom right corner of the image.

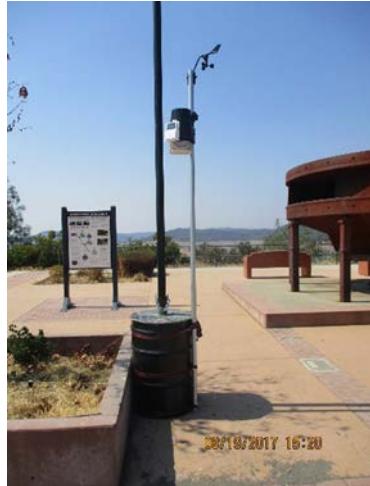
A photograph of Weather Station #1 (WP 045A) located at Oroville Dam. The station is mounted on a tall black pole. In the background, there is a paved area with a red circular structure, a trash can, and a small signpost. The date and time '08/19/2017 16:20' are overlaid at the bottom of the image.

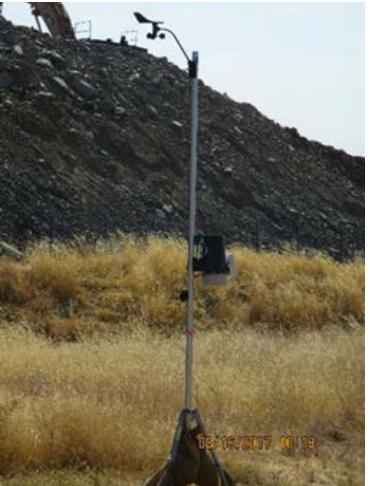
A photograph of Weather Station #2 (WP 044A) located in a field. The station is mounted on a tall black pole. The background shows a hillside covered in dry grass and rocks. The date and time '08/19/2017 16:18' are overlaid at the bottom of the image.
Weather Station #1 – WP 045A	Weather Station #2 – WP 044A

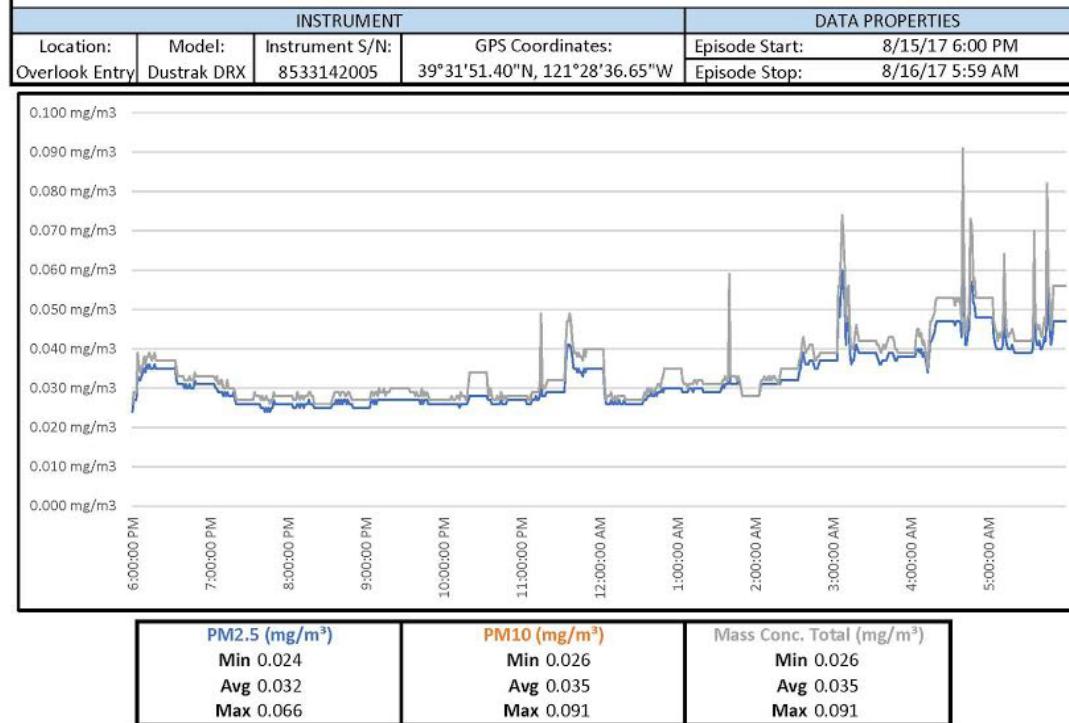
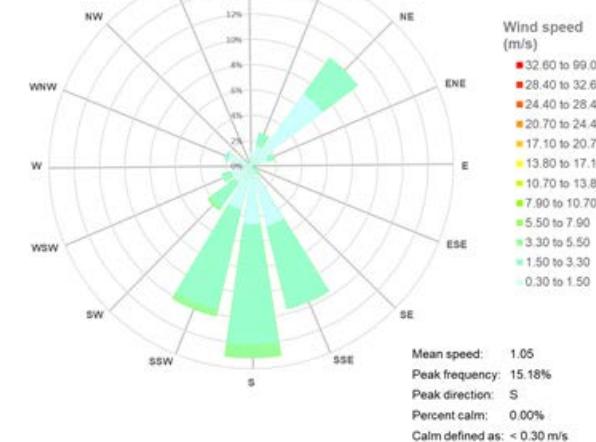
WP 247 Upper Overlook Entry

WP 247 Upper Overlook Entry, WP 248 Upper Overlook & WP 249 Canyon Drive							
Sample ID	Location	Non-Asbestos Structures	Asbestos Types	# Structures		Analytical Sensitivity (S/cc)	Asbestos Concentration (S/cc)
				$\geq 0.5 \mu\text{m} < 5 \mu\text{m}$	$\geq 5 \mu\text{m}$		
0815-OFD-PMT-06	WP247 Upper Overlook Entry PM Shift	11	Actinolite	4	5	0.0010	0.0087
		Non-asbestos structures reported above includes a contribution from non-regulated amphiboles					
0815-OFD-PMT-07	WP248 Upper Overlook PM Shift	8	Actinolite	7	4	0.0010	0.0110
		Non-asbestos structures reported above includes a contribution from non-regulated amphiboles					
0815-OFD-PMT-08	WP249 Canyon Drive PM Shift	7	Actinolite	6	2	0.0010	0.0077
		Non-asbestos structures reported above includes a contribution from non-regulated amphiboles					
Investigative & Corrective Actions	WP247 Upper Overlook Entry 08/15/2017 Night Shift: <ul style="list-style-type: none"> • 2233 No work activity near air monitoring station observed by technician per field notes. • 0310 No work activity near air monitoring station observed by technician per field notes. Road is dry. WP248 Upper Overlook 08/15/2017 Night Shift: <ul style="list-style-type: none"> • 2229 Vehicle traffic observed on dry aggregate covered parking area creating visible dust emissions. • 0306 No work activity near air monitoring station observed by technician per field notes. WP249 Canyon Drive 08/15/2017 Night Shift: <ul style="list-style-type: none"> • 2240 Vehicle traffic observed traveling on Canyon Drive. • 0320 No work activity near air monitoring station observed by technician per field notes. Corrective Actions: <ul style="list-style-type: none"> • Notify DWR of the event. • Increase water application for dust suppression at parking area to reduce airborne fiber counts. • Identify origin of aggregate covering the parking area, conduct bulk sampling if needed.

DWR OROVILLE WS1 - 2017.08.15 Night Shift

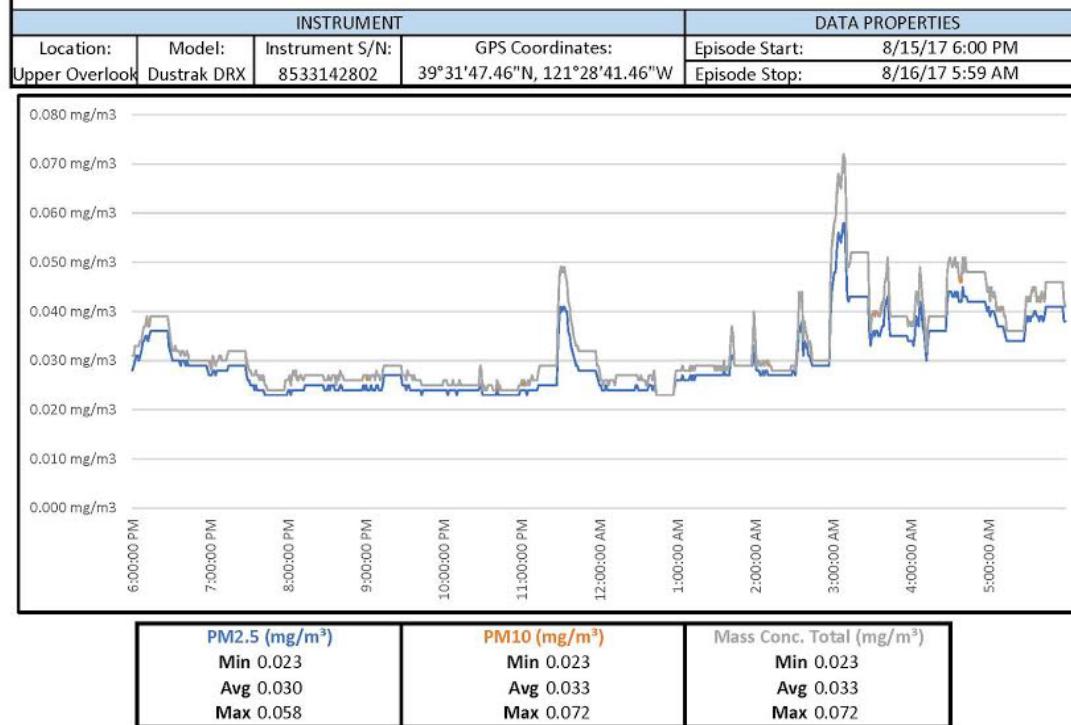
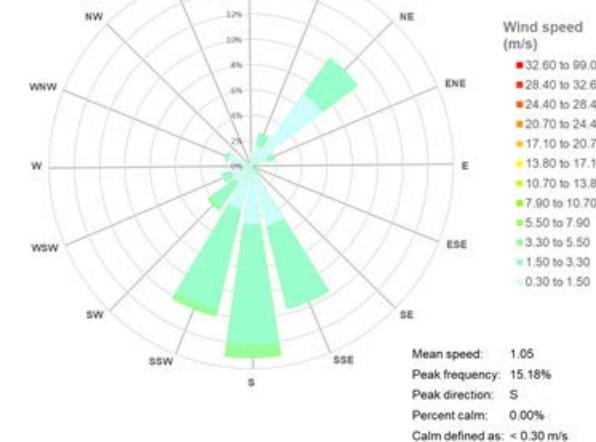
WP 248 Upper Overlook

DWR OROVILLE WS1 - 2017.08.15 Night Shift

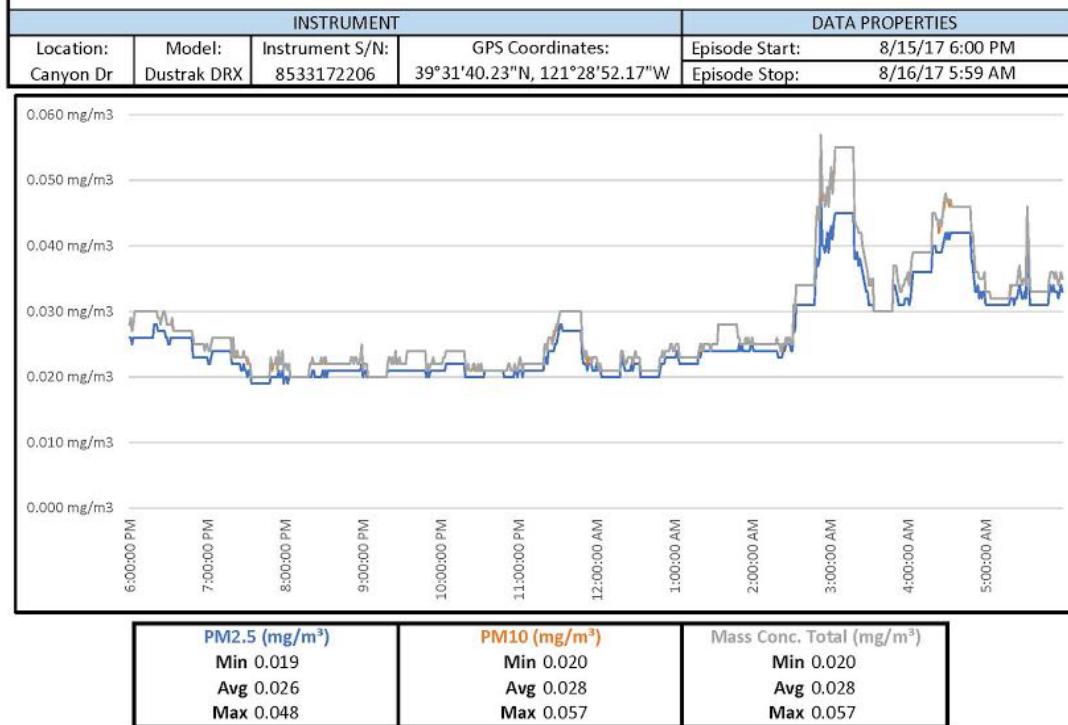
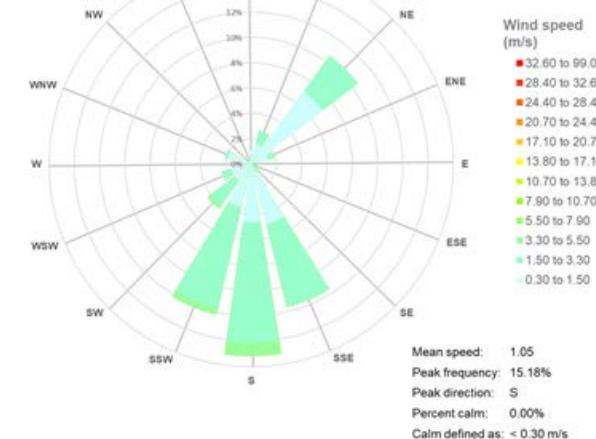
WP 249 Canyon Drive

DWR OROVILLE WS1 - 2017.08.15 Night Shift

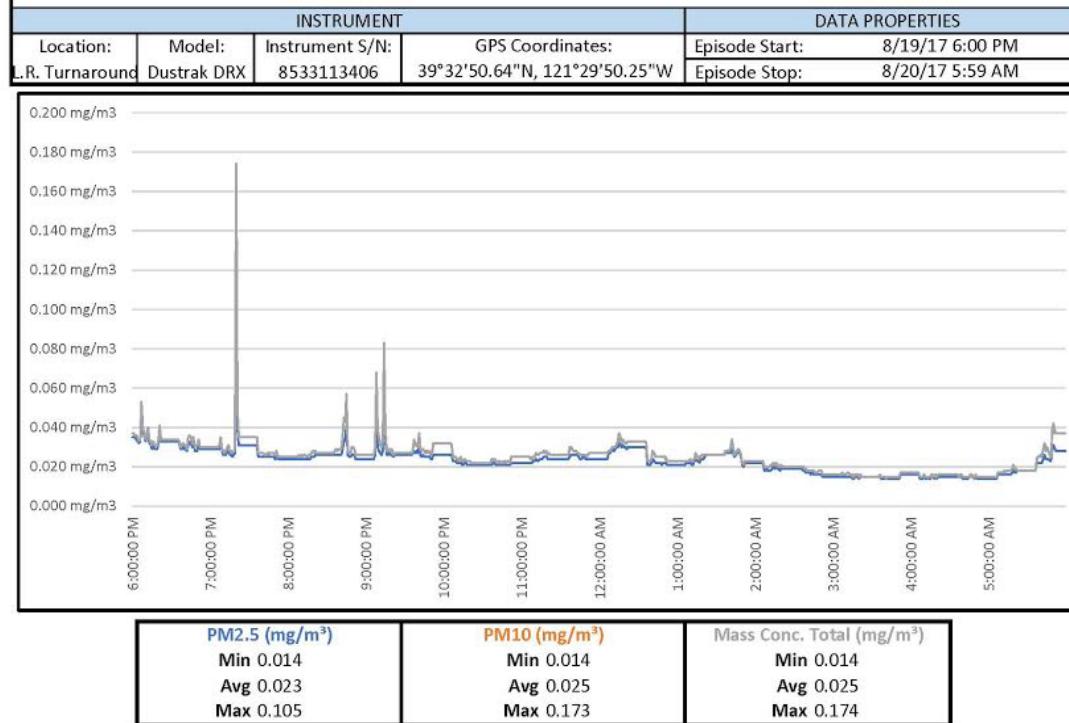
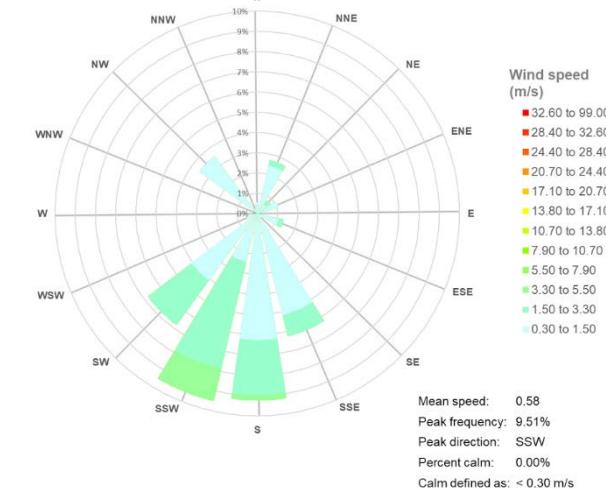
WP 010A Launch Ramp Turnaround							
Sample ID	Location	Non-Asbestos Structures	Asbestos Types	# Structures		Analytical Sensitivity (S/cc)	Asbestos Concentration (S/cc)
				$\geq 0.5 \mu\text{m} < 5 \mu\text{m}$	$\geq 5 \mu\text{m}$		
0819-OFD-LRP-04	WP010A Launch Ramp Turnaround PM Shift	4	Actinolite	1	5	0.0010	0.0059
Investigative & Corrective Actions	WP010A Launch Ramp Turnaround 08/19/2017 Night Shift: <ul style="list-style-type: none"> • 2205 Drilling operations for the secant wall construction downhill (south) of air monitoring station observed by technician per field notes. • 0236 No work activity observed by technician per field notes. The drilling operations near station were shut down. Corrective Actions: <ul style="list-style-type: none"> • Notify DWR of the event. • Implement NOA dust control measures during construction activities. • Increase water application during night shift for dust suppression.

DWR OROVILLE WS1 - 2017.08.19 Night Shift

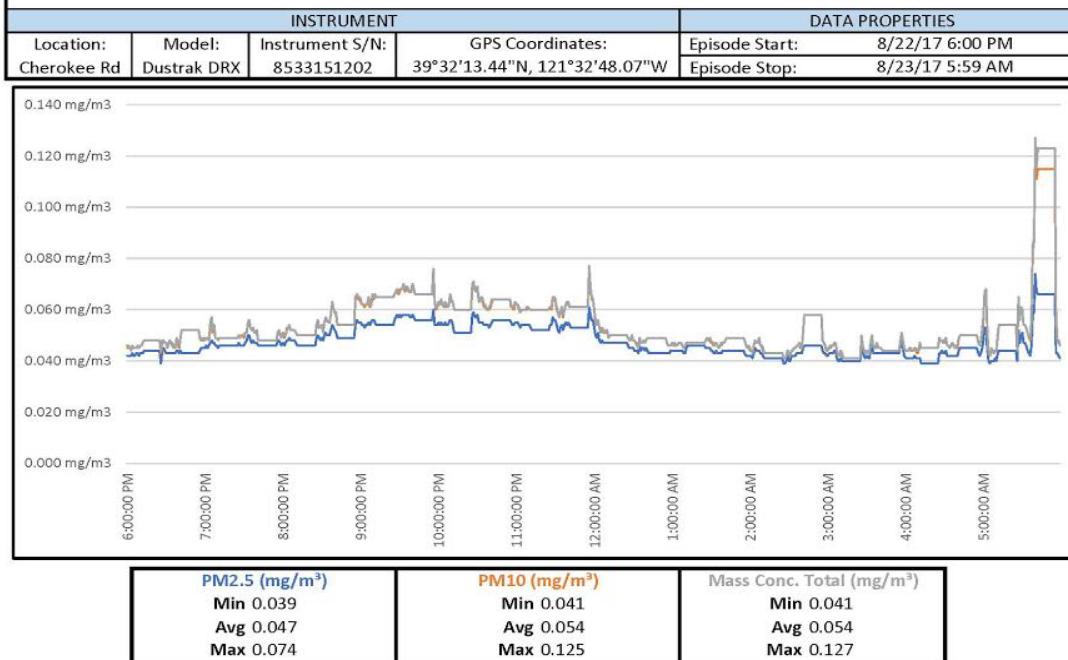
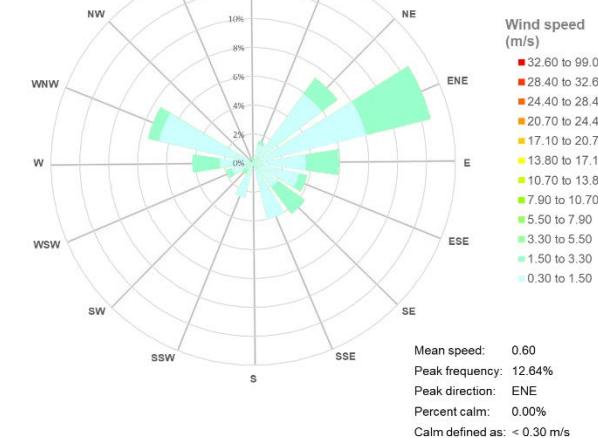
WP 281 Cherokee Rd							
Sample ID	Location	Non-Asbestos Structures	Asbestos Types	# Structures		Analytical Sensitivity (S/cc)	Asbestos Concentration (S/cc)
				$\geq 0.5 \mu\text{m} < 5 \mu\text{m}$	$\geq 5 \mu\text{m}$		
0822-OFD-TPT-16	WP281 Cherokee Rd. PM Shift	0	Actinolite	4	1	0.0010	0.0050
Investigative & Corrective Actions	WP281 Cherokee Rd 08/22/2017 Night Shift: <ul style="list-style-type: none"> 1945 No work activity observed by technician per field notes. Light plant running on access road below station and vehicle traffic on Cherokee Rd was documented on the field notes. 2031 A large cloud of dust was observed by the technician off the project site west of the perimeter which potentially could have contaminated the sample during the shift. 0050 No work activity observed by technician per field notes. Light plant running on access road below station and vehicle traffic on Cherokee Rd was documented on the field notes. Wildlife (deer) was observed near the air monitoring station. No construction activity was observed by the technician at the Diversion Dam area during the PM shift. Corrective Actions: <ul style="list-style-type: none"> Notify DWR of the event. Increase water application during night shift for dust suppression.

DWR OROVILLE WS2 - 2017.08.22 Night Shift
