Air Quality Monitoring and Sampling Summary Report

Air Quality Monitoring of the Work Zone Perimeter and Localized Weather Patterns

DWR Oroville Dam Recovery Operations

December 27, 2019 through January 9, 2020

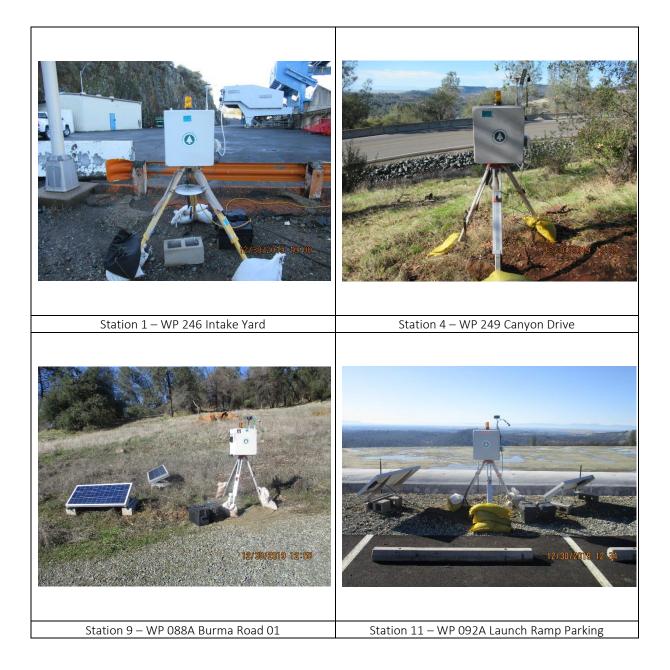
Table 5 Photo Documentation of Air Monitoring Stations and Weather Stations – Current Condition

Station 12 – WP 081A Launch Ramp Turnaround	Station 24 – WP 083A Dan Beebe Trail
	Intentionally Left Blank
Station 25 – WP 091A Upper Overlook	Intentionally Left Blank
